WILSON CREEK DAM

NDI - PA 00318
PA DER 52-154
SCS PA - 440

PHASE I INSPECTION REPORT NATIONAL DAM INSPECTION PROGRAM

MAY 1979

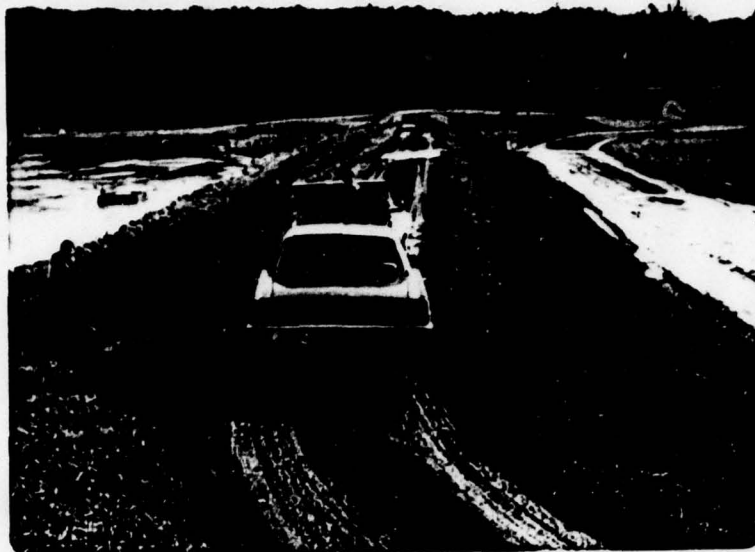
*VIEW LOOKING ACROSS THE TOP OF THE DAM FROM
THE RIGHT ABUTMENT*

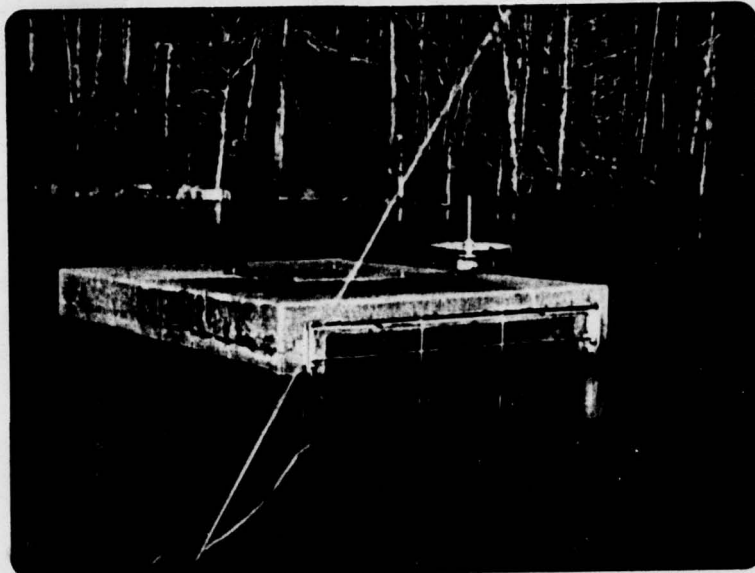
***DETAILS OF THE SINGLE STAGE DROP INLET
OF THE PRINCIPAL SPILLWAY***

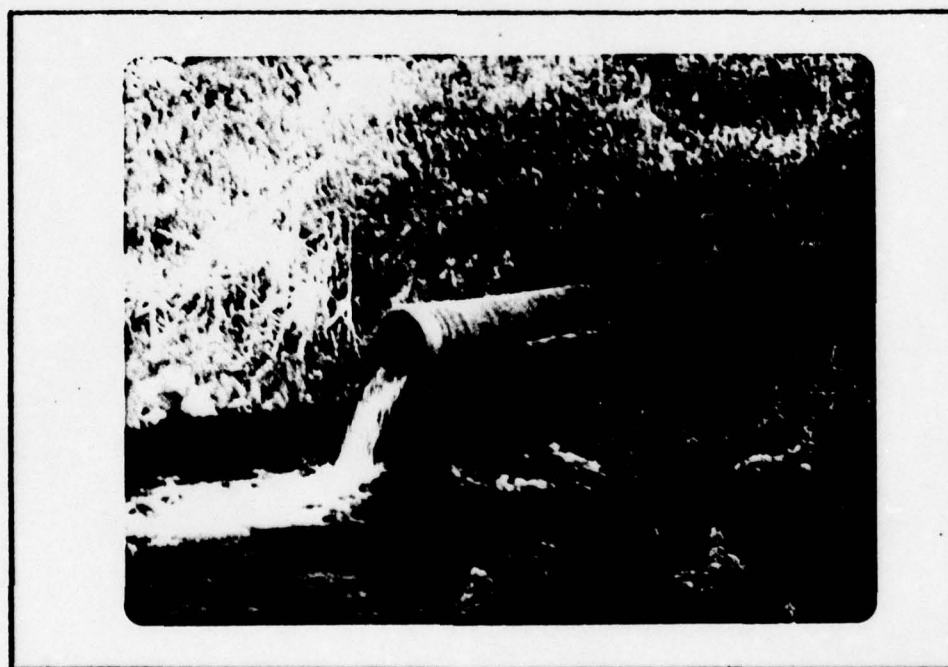
*CLOSE UP OF THE PRINCIPAL SPILLWAY OUTLET
SHOWING A DRAINAGE SYSTEM OUTLET PIPE*

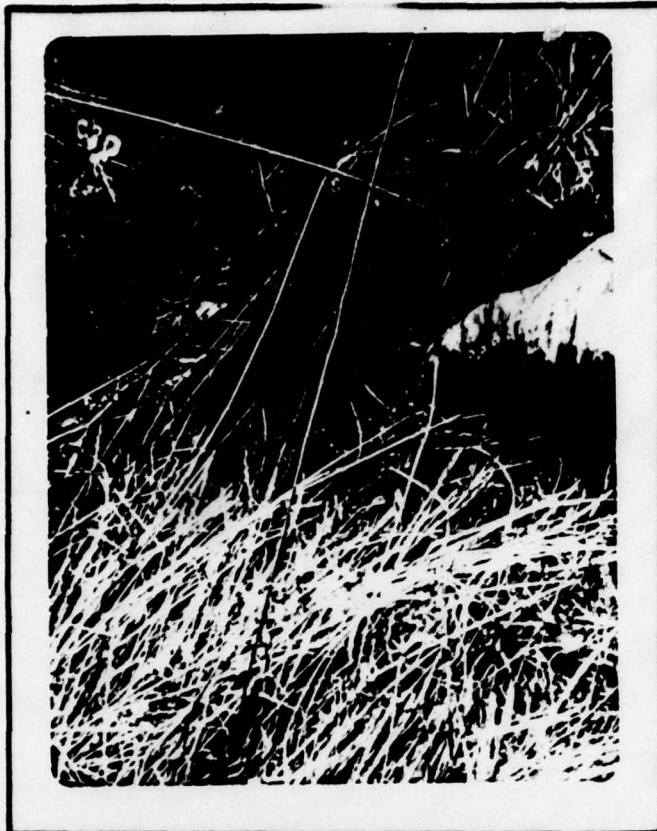
- b. Dam. The dam is in good condition. There are minor undulations (+ 0.5 feet) along the top of the dam and along both the upstream and downstream earth embankment slopes. There is slight seepage on the downstream earth embankment slope around the principal spillway conduit.

*TOKEN SEEPAGE DOWNSTREAM OF THE
RIGHT ABUTMENT*

1. There is slight seepage around the Principal Spillway conduit where the conduit projects from the downstream face of the dam. According to the plans, a trench backfilled with filter material is located along the conduit. Apparently the filter was capped with an earth cover at the downstream toe. It is recommended that minor excavation be performed at the outlet to examine the filter drain and determine if a riprap cover would be appropriate.
2. There is some erosion at the downstream end of the stilling basin. Riprap should be added to prevent further erosion.
3. The operating condition of the reservoir drain sluice gate should be assessed. The owner should provide access to the riser in order to operate and maintain the gate system.
